PREVENTION OF ELECTRIC DISTURBANCES IN THE OBSERVATORY
NEAR NAGYCENK*Gy. März—J. Veró*

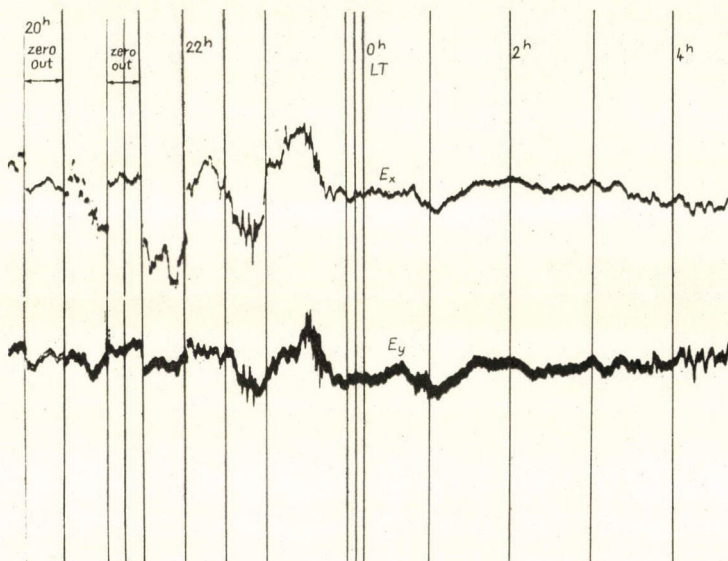
Fig. 4. Disappearance of the disturbances with zero out

As the experiments described earlier did not bring the effect waited, the neutral line was suspected to be the source of the disturbances. An evening the neutral line was cut several times. The effect was that the disturbance existed only during the neutral line was switched on (Fig. 4). Now only the search for the grounding of the neutral line must be carried out, and after its elimination the disturbances ceased, too. The neutral line was grounded by an outsider electrician in November 1968 for safeguarding.
